NDE METHOD FOR CHARACTERIZING ANODIZED A1 SURFACES

ROCKWELL INTERNATIONAL SCIENCE CENTER
1049 CAMINO DOS RIOS
THOUSAND OAKS, CALIFORNIA 91360

TECHNICAL REPORT AFML-TR-78-146
Final Report for period 1 September 1977 through 31 July 1978

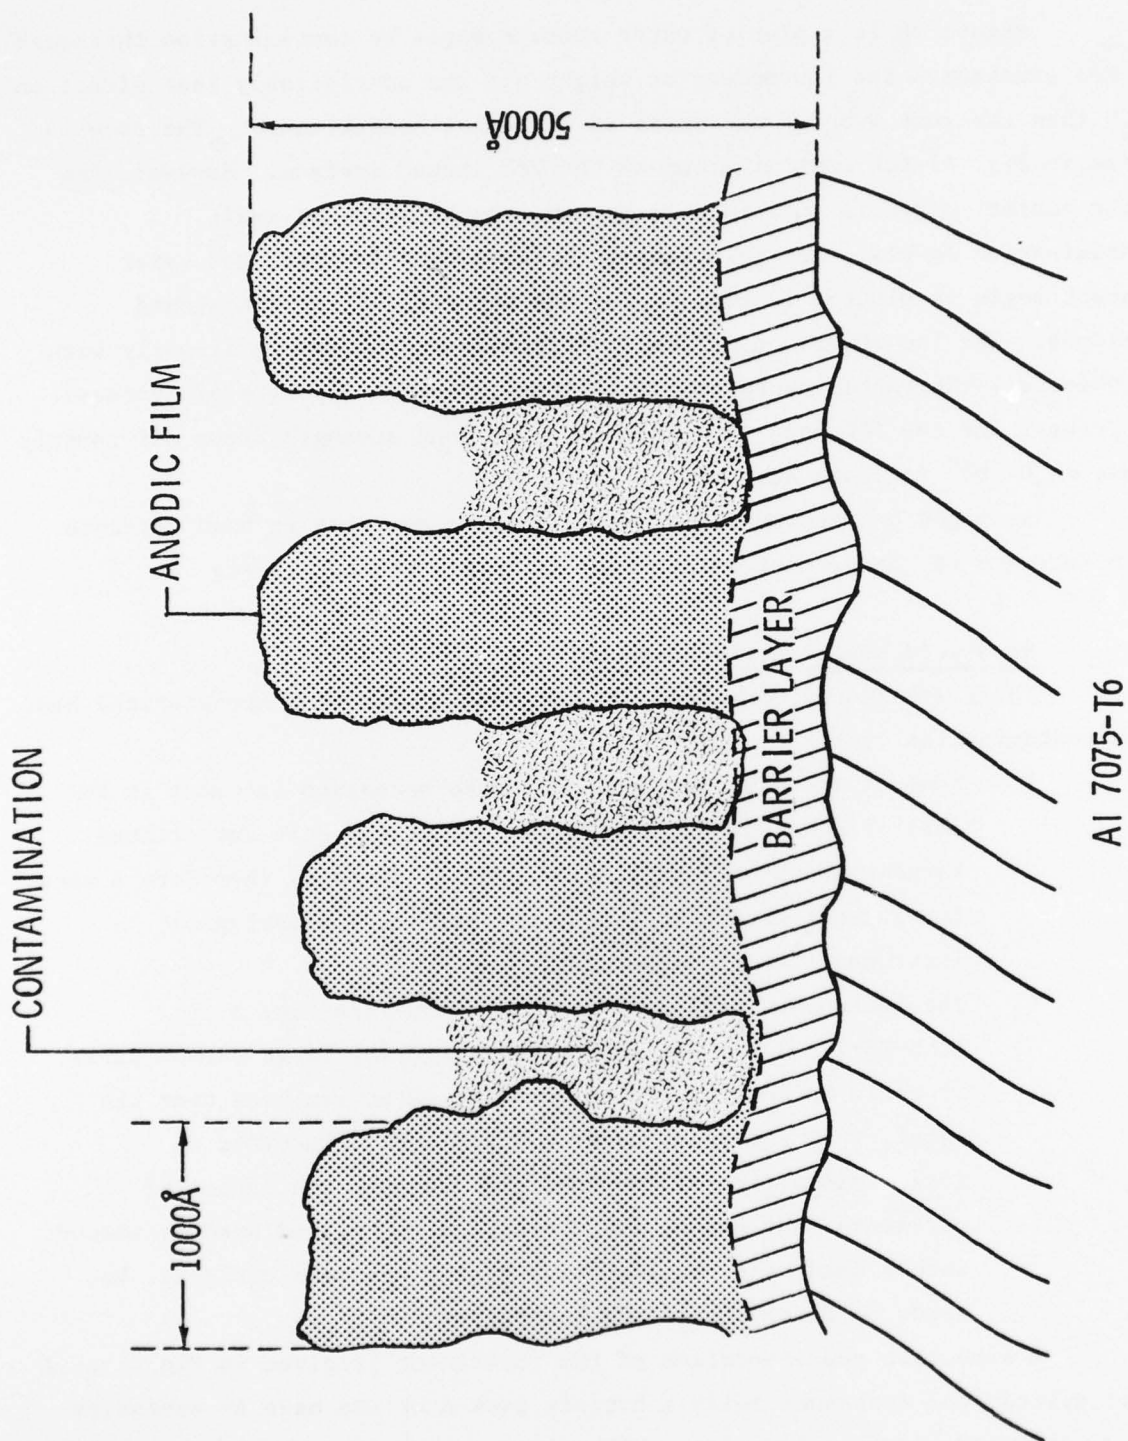
Fig. 39 Schematic representation of phosphoric anodized Al 7075-T6.

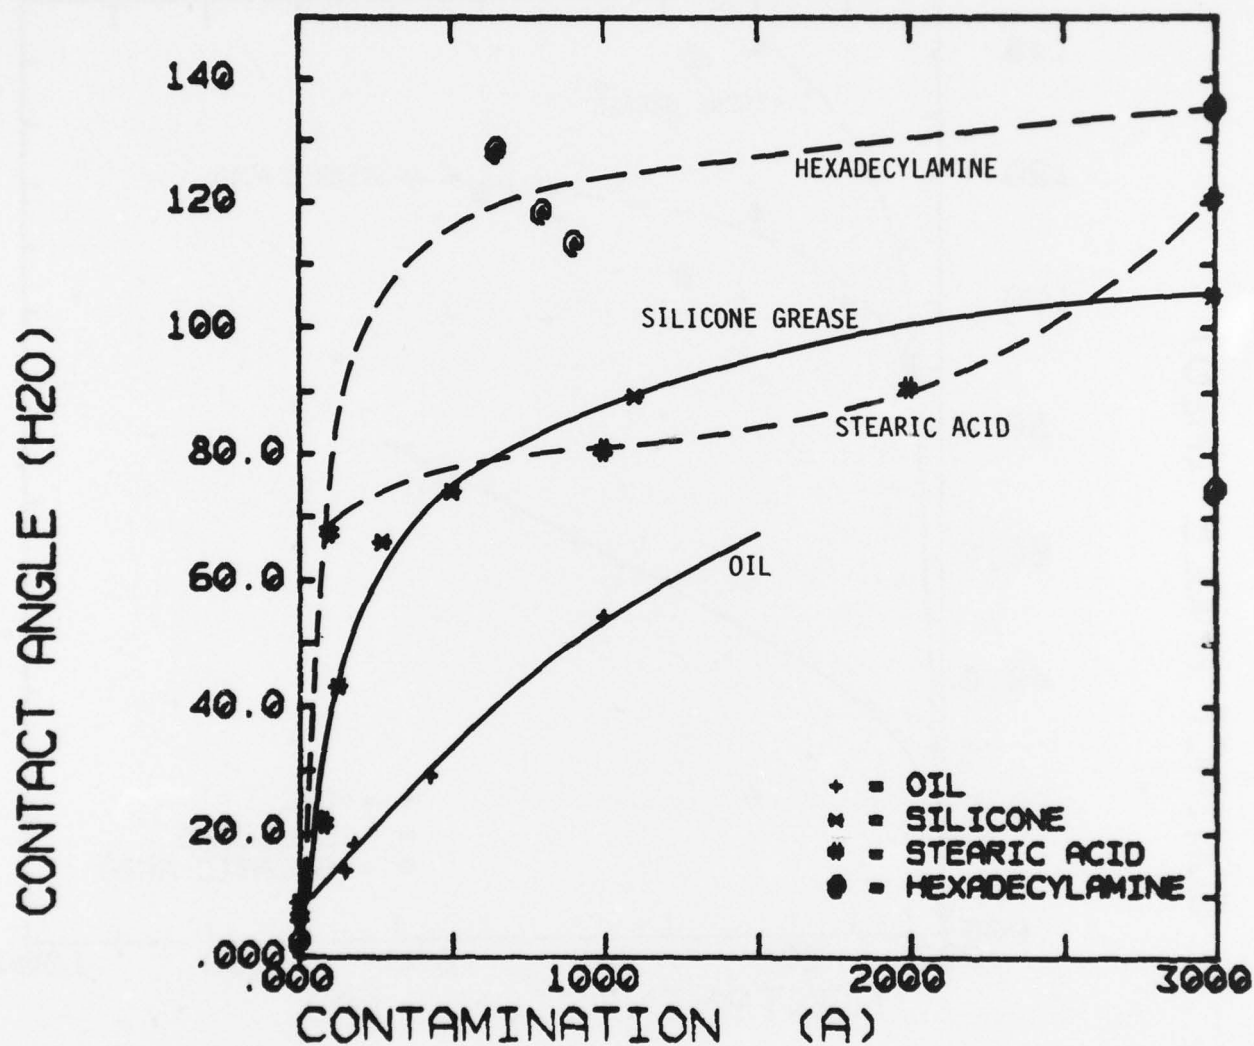
Fig. 40 Contact angle vs. contamination for PAA AL 7075-T6.

Figure 40 is a plot of water contact angle vs contamination thickness on PAA aluminum. The low molecular weight oil has considerably less effect on θ_{H_2O} than the same average thickness of the other contaminants. The same is noted in Fig. 41 for contamination on the FPL etched surface. However, the water contact angle is increased to a much greater value at small contamination levels. The relationship between bond strength and water contact angle is plotted in Fig. 42 for PAA and Fig. 43 for FPL etched surfaces. The lap shear bond strength decreases approximately linearly with θ_{H_2O} for all the contaminants except silicone grease. The rate of decrease is greater for the FPL etch than the PAA. The bond strength drops off sharply above $\theta_{H_2O} \sim 60^\circ$ for both surfaces.

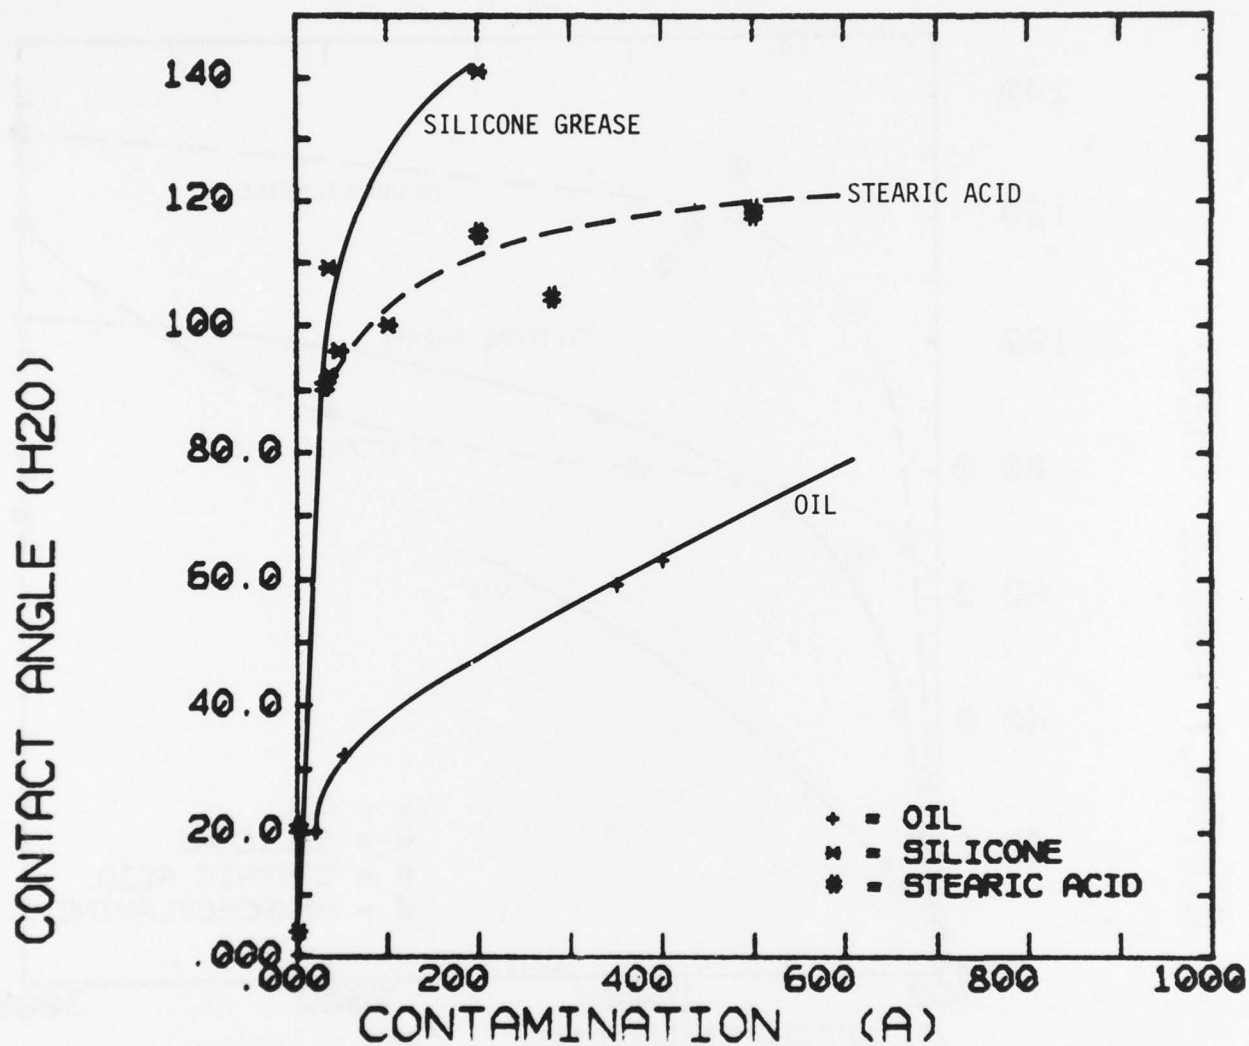
Fig. 41 Contact angle vs contamination for FPL etch AL 7075-T6.

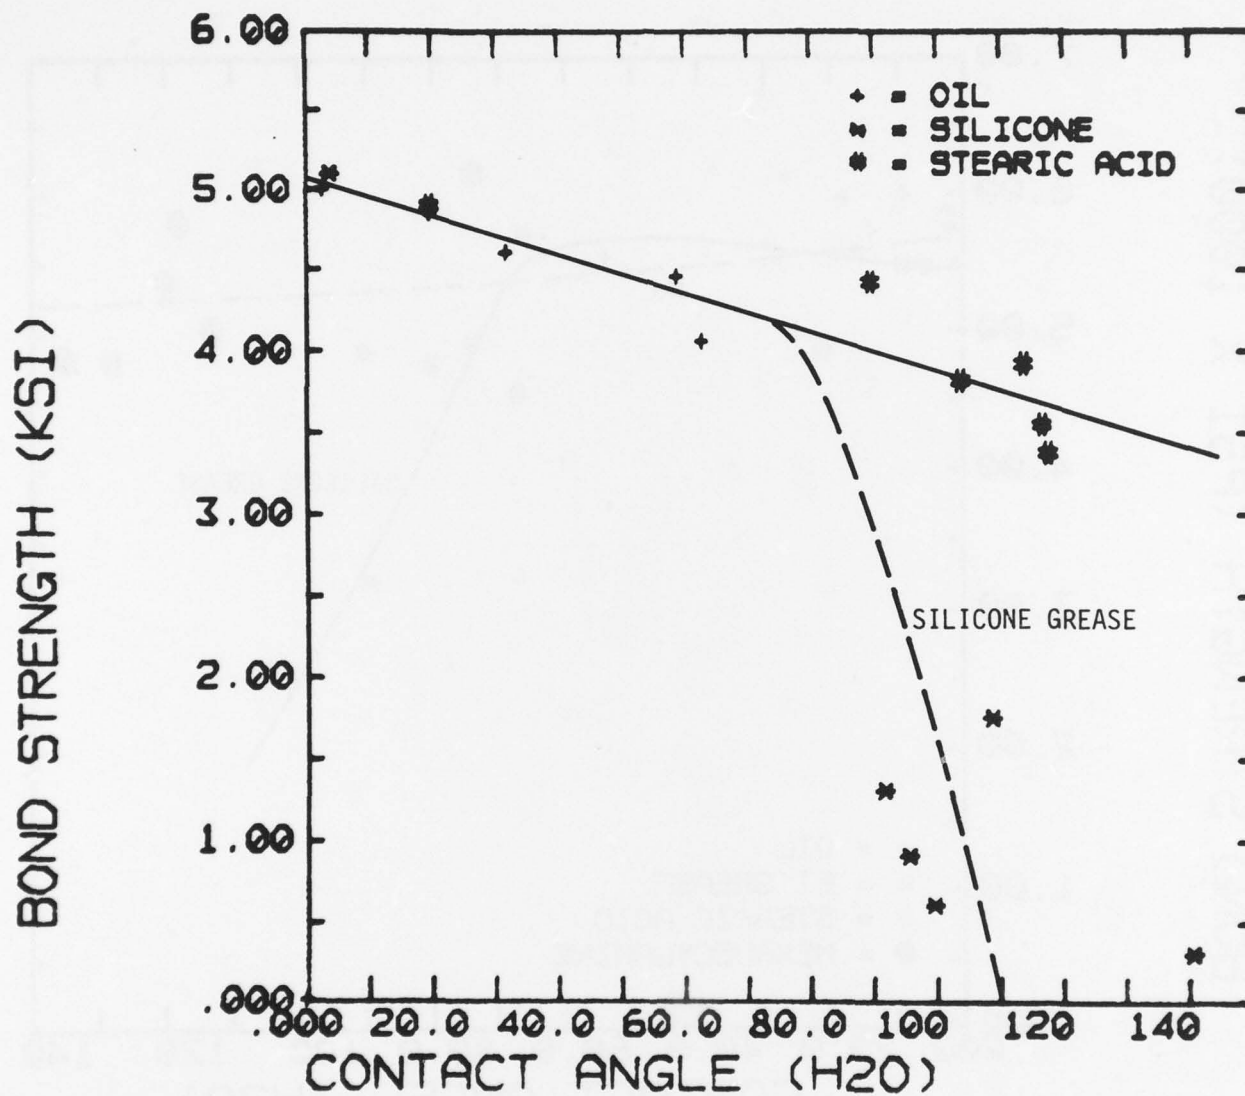
Fig. 42 Bond strength vs. contact angle for FPL etch AL 7075-T6.

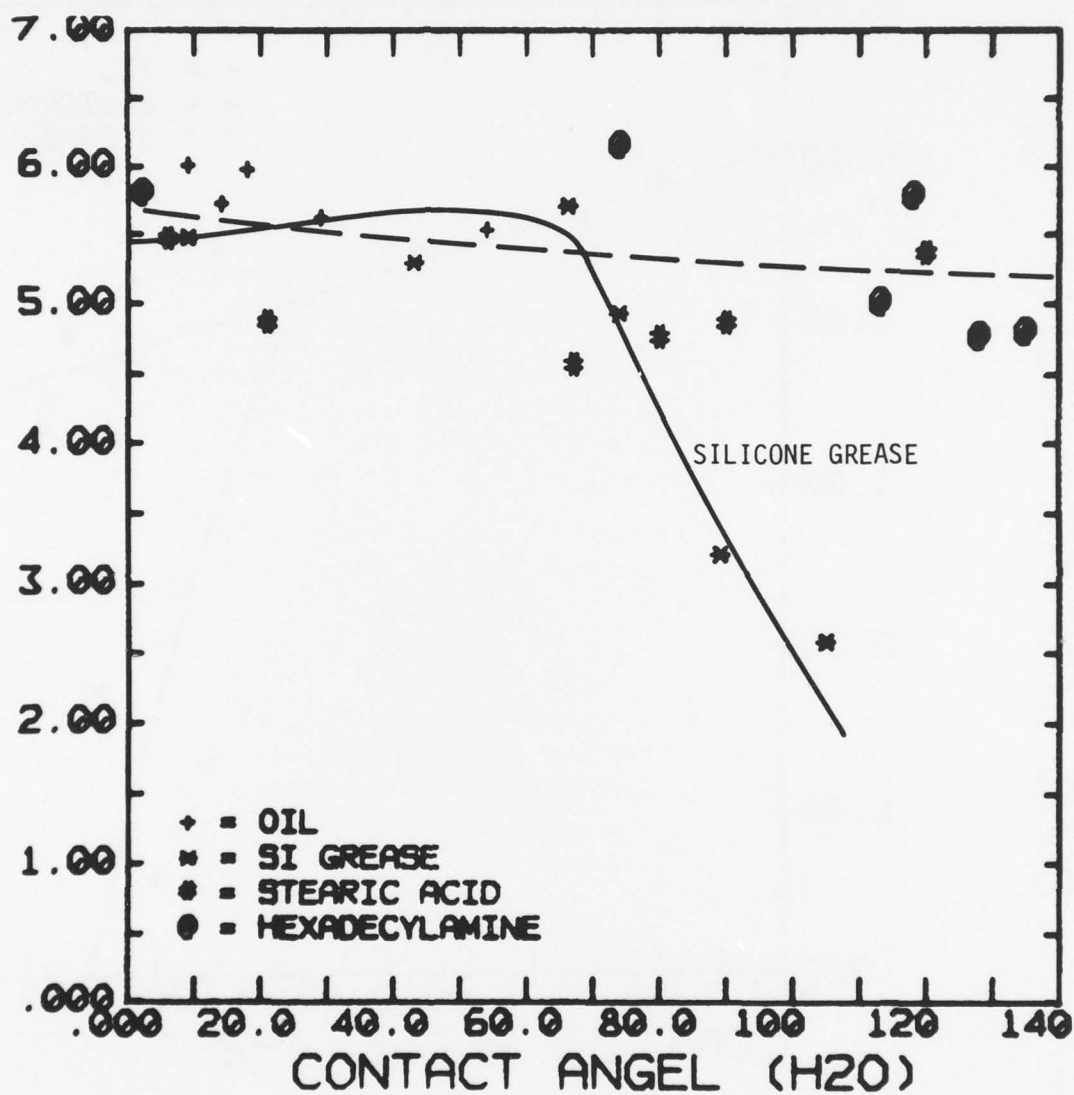
Fig. 43 Bond strength vs contact angle for PAA AL 7075-T6.

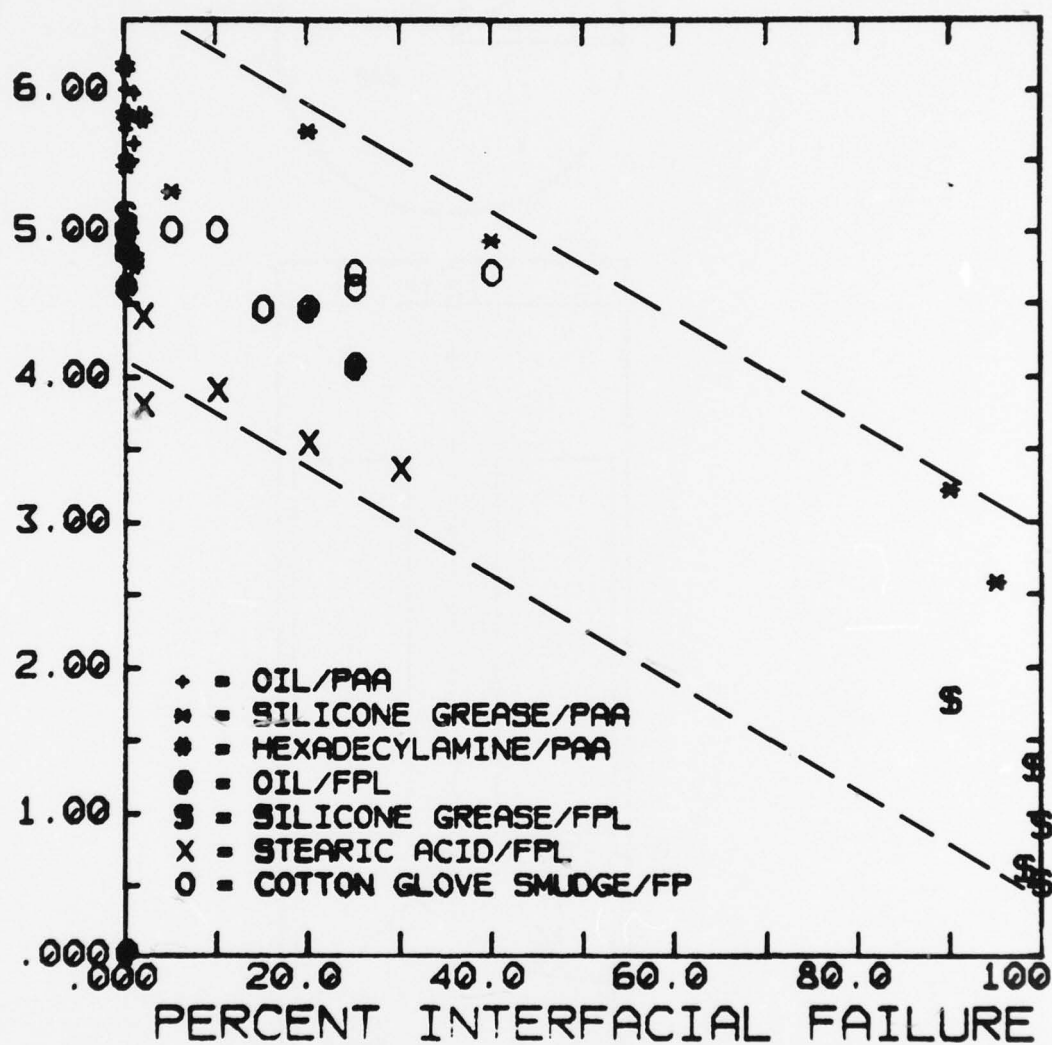
Fig. 44 Bond strength vs % interfacial failure.

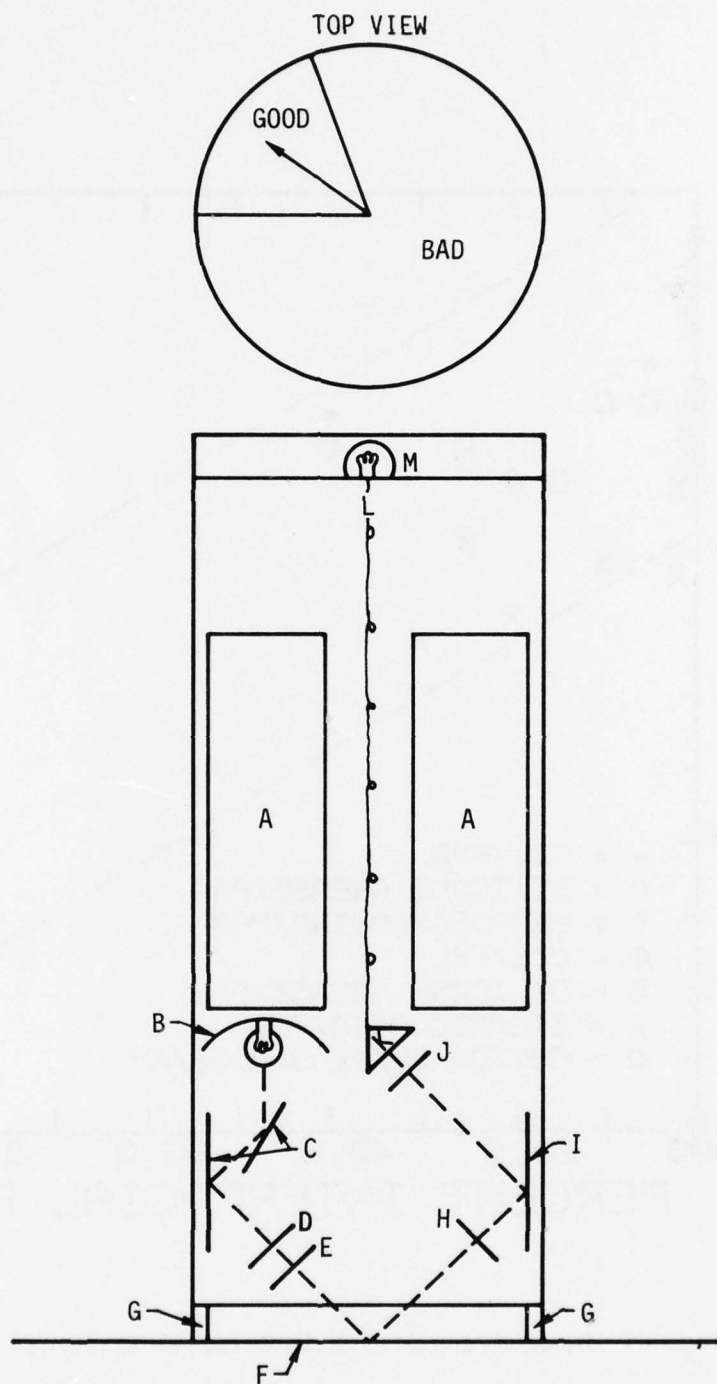
Fig. 45 A schematic presentation of the Off Null ellipsometric contamination tester.

A schematic representation of the instrument is given in Fig. 45. A small cylindrical container holds a battery pack A or can have an extension cord to standard electrical outlets. The power source is connected to a lamp

and reflector B that reflects light off mirrors C and through a polarizer D and compensator E. The light passes through a window in the bottom of the instrument and reflects from the surface F, to be tested. The feet G are placed against the surface to provide a precise angle of incidence for the beam. If the surface cannot be touched, it will be necessary to provide mechanical arm and holder that position the tester in the correct orientation with respect to the surface. The alignment technique is described below.
